SIGNAGE INVENTORY DATABASE AND PLAN

Improving the signage system along the Sunset Bike
Route in Peninsula State Park

Urban Planning and Policy Master's Project, University of
Illinois at Chicago Graduate College

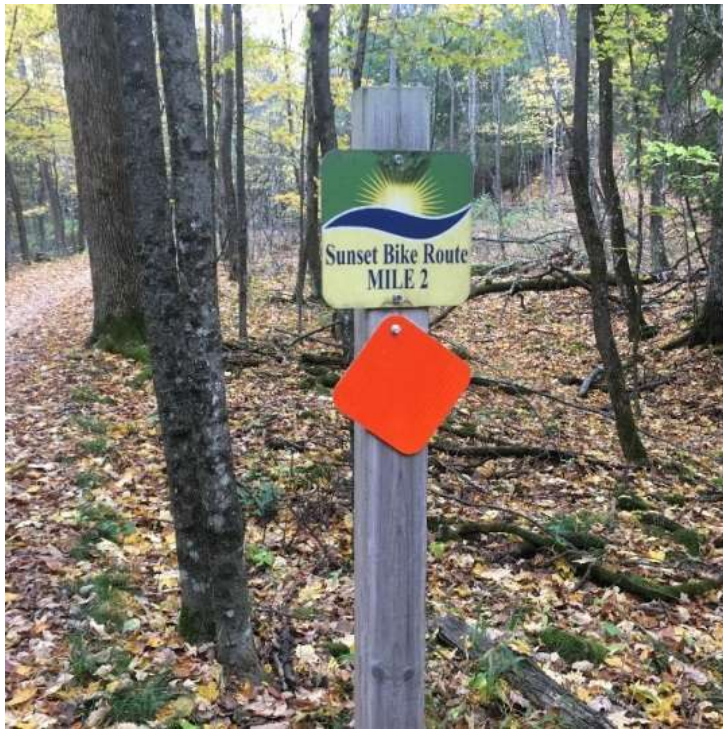
Image 2: Sunset Mile Marker and Orange Blaze

OID	65/66
Sign Number	48.0/48.1
Area – Trail	SS
Code	TM/TM
Latitude	87.2409821
Longitude	45.1496544
Altitude	202.19
Path	IMG_0900
Color	MULTI/OR
Detail	Mile 2/Orange Blaze
Direction	NB
Position	RIGHT
Install	2010/2015
Cost	\$18/\$13
Post	01/01
Face	01/01
Letters	01/01
Reflectivity	02/01
Visibility	01/01
Material	Aluminum/Aluminum
Reflectivity Grade	Engineer Grade/Prismatic
Useful Life	12/10
Current Year	2016
Remaining Life	6/9
Replacement Year	2022/2025

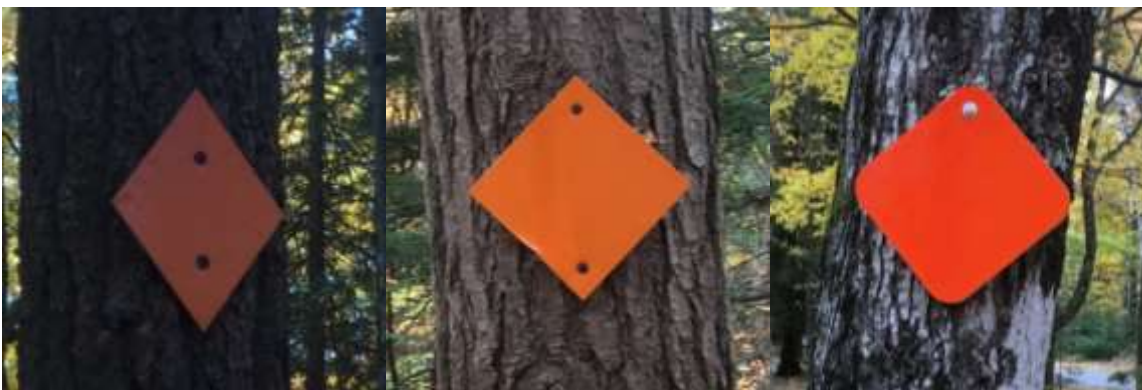
Using the images collected it was clear which signs (specifically in cautionary and trail markers – orange blazes) were newer. These signs were given an installation date of 2015 and all signage was back dated from that based on its condition and the number of its type in the park. For example, the orange blazes have 3 different installation dates based on the types of blazes found. Images 6-8 show the different types of blazes:

Image 5: 2005 Blaze

Image 6: 2011 Blaze

Image 7: 2015 Blaze

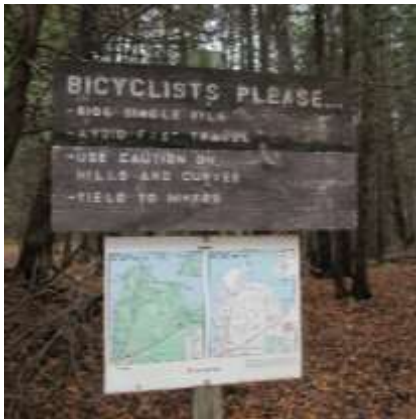
Sign # 6.0 & 6.1

- 1) There are a total of 36 wooden signs associated with the Sunset Bike Route. 6 of these signs are fading or have signs of deterioration and may eventually be illegible. The deterioration of wooden signs negatively affects the perception that the park is well taken care of. The following images show a few of these signs:

Repaint deteriorating wooden signs

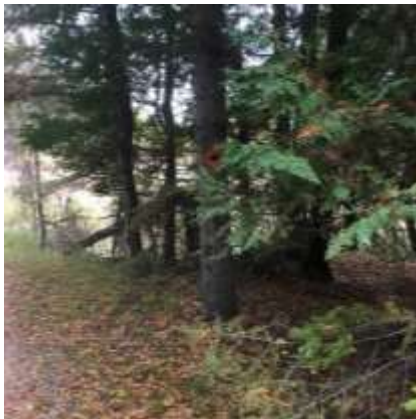
Sign # 18.0

- 2) 8 orange blazes and arrows marking the snowmobile route are hidden by tree limbs and in one case a curve in the road (Sign #292). No other signs other than those associated with the snowmobile trail are positioned where they cannot be seen. The following images show a few of these signs:

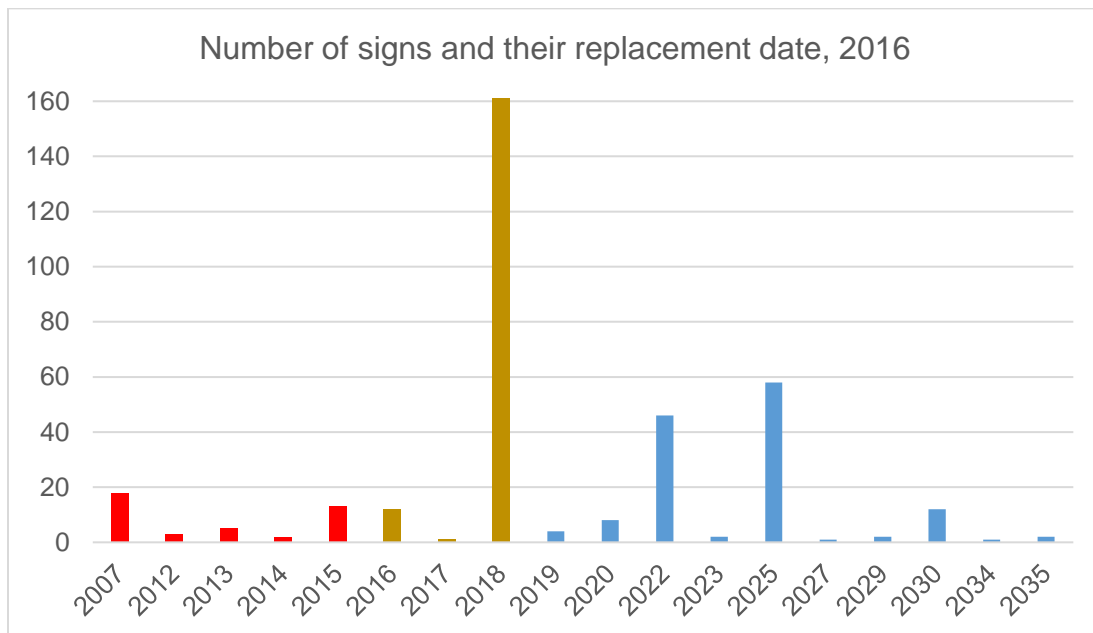
Using estimated installation dates and lifetimes of different reflectivity grades the useful life could be identified resulting in a projected replacement date. Chart 1 provides a breakdown of the number of signs and their replacement dates:

There are 41 signs with a lapsed replacement date, these are highlighted in red. Yellow represents signs that are scheduled for replacement within the next two years. A strong majority of signs should be scheduled to be replaced in 2018. This includes many of the engineer grade orange blazes that were installed in 2011.

Over 160 signs are scheduled to be replaced in 2018. The park should begin budgeting in the replacement or at the very least the evaluation of these signs to be replaced in the next year's budget.

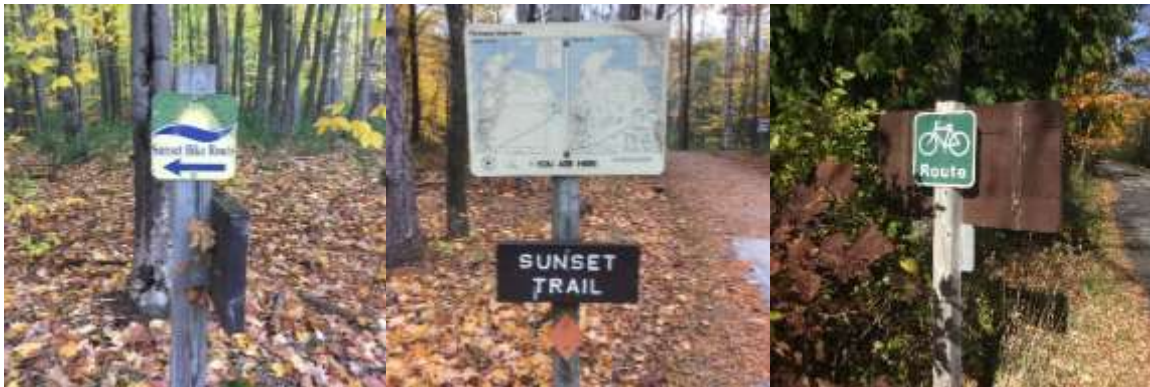
- 1) Trail markers specific to the Sunset Bike Route are not uniform. Some are legacy signs that remain from the previous trail signage before the latest trail markers were installed. Below displays some of the inconsistencies:

Sign # 40.0

Sign # 30.0, 30.1, 30.2

Sign # 200.0

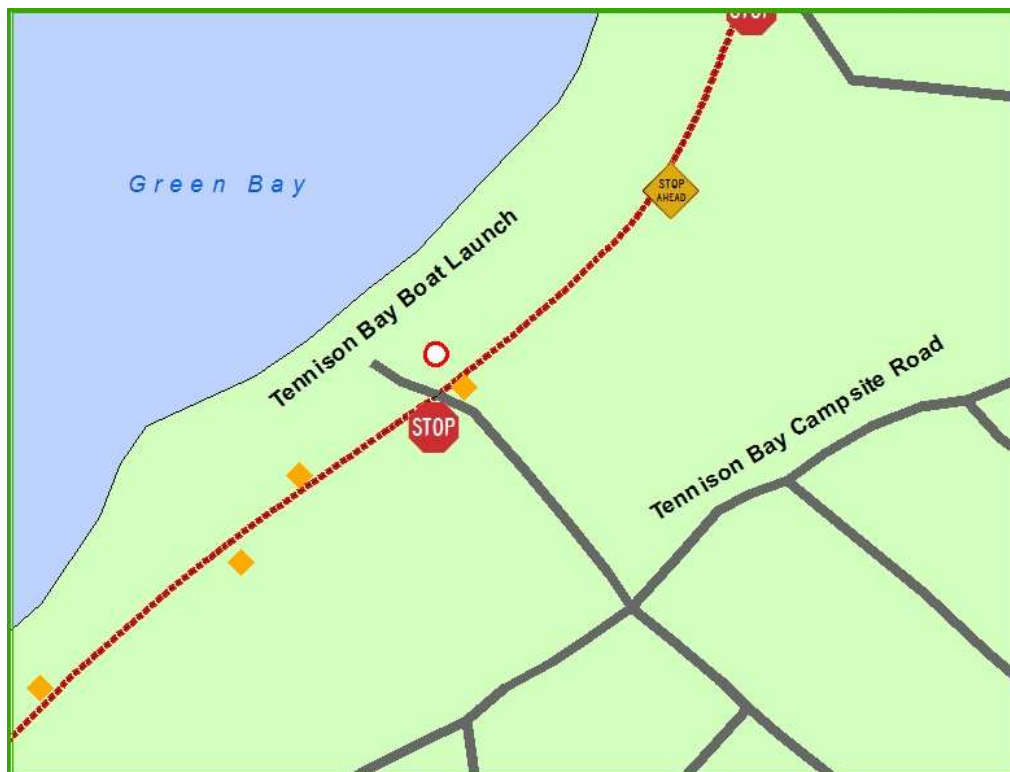
Tennison Bay Boat Launch Intersection with the Sunset Bike Trail

- 2) An intersection connecting the trail to a boat launch and campsite has one trail stop sign positioned for northbound riders but does not have a stop sign in the southbound position. Map 2 displays the intersection where there is no southbound stop sign. A full map of the area’s relative location in the park is provided in **Appendix D**.

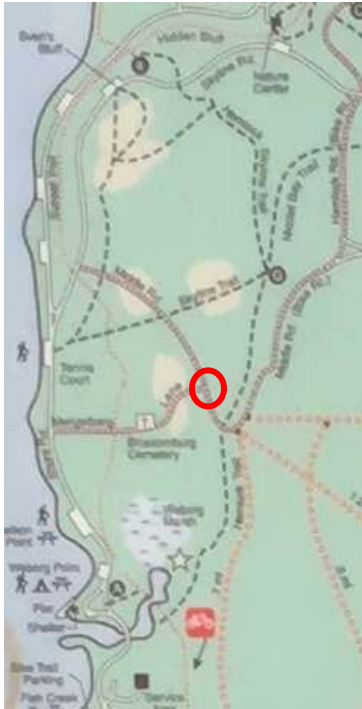
Map 4: Current trail route

- 3) Some park maps display Sunset Bike Trail as turning left at the intersection of Middle Road and Mengelberg Lane while others show the bike path traversing down either Middle Road or Mengelberg Lane. When riders reach the intersection the signage directs them to take Middle Road. The images below show the inconsistencies in mapping.

The Sunset Bike Trail route needs to be updated on a majority of park maps along the trail to ensure that users travel along Middle Road which is the road indicated by the on-trail markers. Additionally, there are some maps that are beginning to deteriorate and are illegible or laminated and nailed to the posts as quick fixes to updating trails – specifically for winter users. All maps that need to be replaced are included in **Appendix G**. Lastly, the map located at the intersection of Middle Road and Sunset Bike Route should be repositioned to better serve the intersection. Currently the map is located across Skyline Road after riders have reached the intersection of Sunset and Middle Road and turned left. The map should be relocated at the top of a small hill that riders would see as they approach the intersection. This location is shown in **Appendix E**.

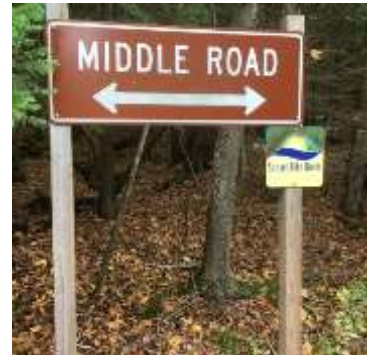
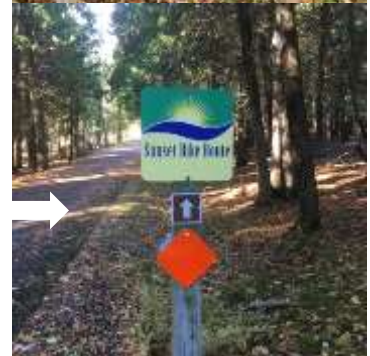
Sign #: 161.1 & 294.0

Signs Located at Intersection

The Middle Road and Sunset Bike Trail intersection also suffers from a poorly positioned map. The intersection is highlighted in **Appendix E**.

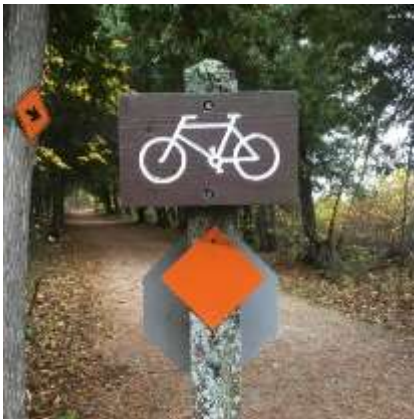
Sign # 93.0

- 4) Orange blazes and arrows are noticeably the most used sign along the Sunset Bike Route, consisting of over 35% of all trail signage. These signs are specifically for snowmobile use but they can appear as markers to guide bicyclists which can result in confusion. A full map of orange blazes can be found in **Appendix F**.

Comprising of over 35% of all trail signage, the orange blazes are the most used sign – but fill the need of the least amount of users. Snowmobile trails are only open for a handful of days during the winter season and the abundance of orange blazes confuses the regular riders of the trail during the spring, summer and fall. It is recommended that the number of orange blazes be reduced to only accommodate signage every quarter mile.

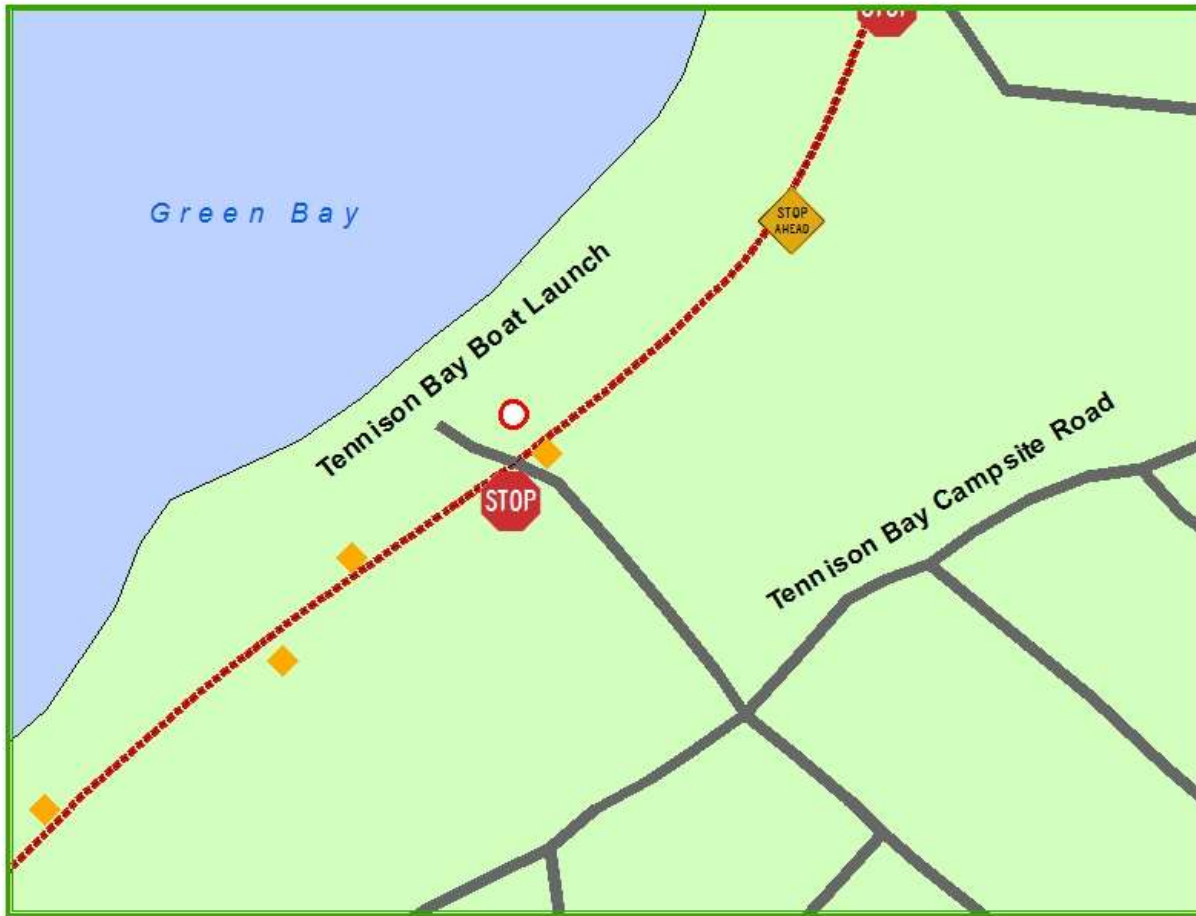
Appendix D: Tension Bay Missing Sign

Intersection of Sunset Bike Route and Tension Bay Campsite Road to Boat Launch

Identification of missing south bound stop sign

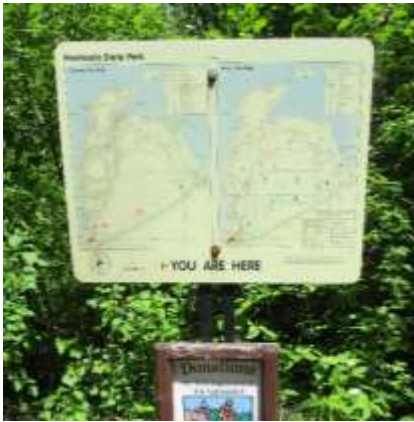
Sign # 2.0 & 2.1

Map signage that needs to be updated with the correct route of the Sunset Bike Trail:

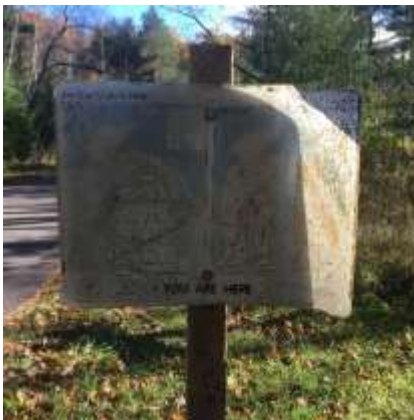
Sign # 277.0

Map signage that needs to be replaced due to illegibility or lamination:

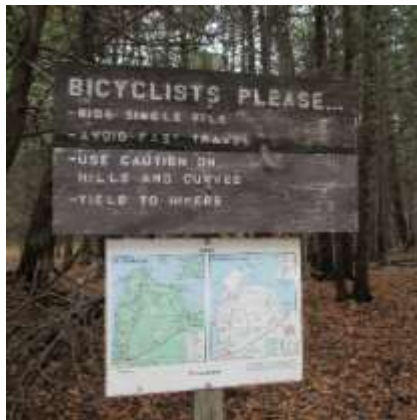
Sign # 6.0 & 6.1

The signs below are recommended to be repainted:
